ENVIRONMENTAL RESTORATION OF A STEEL MILL

J.E. Garlanger¹, A.J. Turner², C. Stern³ and F.K. Cheung¹

Abstract

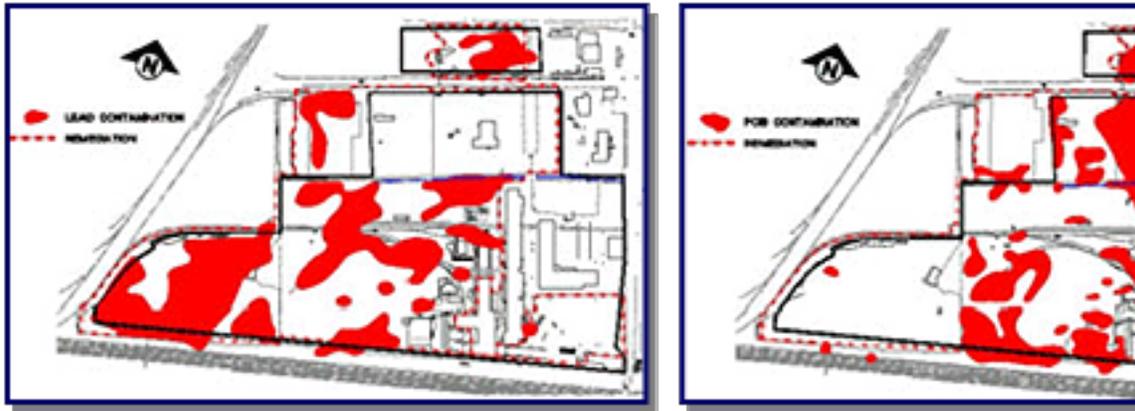
More than 600 test pits/borings and several thousand samples were analyzed during the contamination assessment for the site. The results of the assessment indicated that the fill layer and the sediments in the existing stormwater ditches at the Tampa Mill contained elevated concentrations of lead and PCBs. The lead concentrations ranged from less than 200 to greater than 20,000 mg/kg, and the concentrations of PCBs ranged from less than 10 to greater than 2,500 mg/kg. The areas with lead concentrations greater than 1,000 mg/kg and PCB concentrations greater than 25 mg/kg are shown on Figures 2 and 3, respectively.

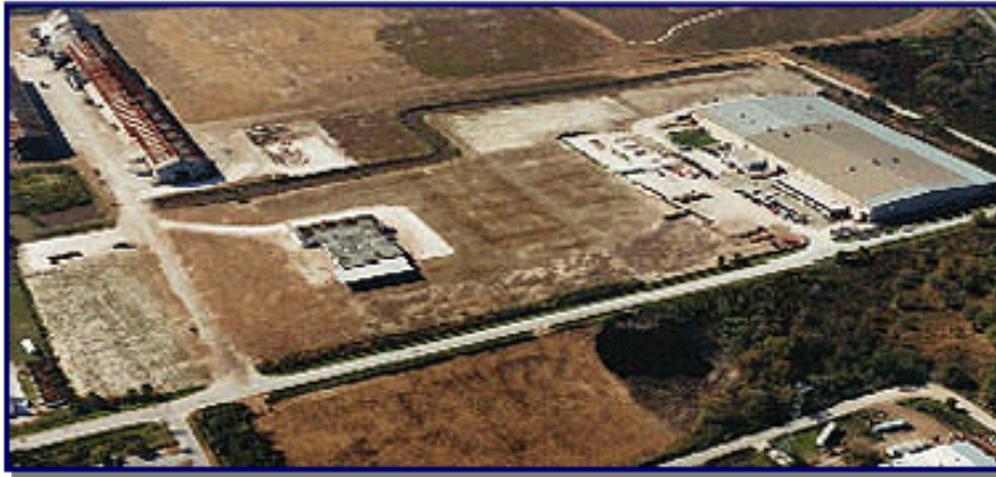
The average depth of excavation for removal of the artificial fill and underlying contaminated soils was approximately 0.75 meters. In some places, the excavation had to be extended to 1.5 meters. The boundary between the artificial fill and the underlying native soils was relatively distinct allowing a high degree of control in the field, as shown on the photograph in Figure 4.

Verification sampling of the native soils underlying the artificial fill was performed on a 15-meter square grid system. If the verification sample exceeded the cleanup requirements, an additional 15 cm of material from that grid was excavated and the procedure repeated until the requirements were achieved.
